ENVIRONMENTAL EXPOSURE OF
SAMPLE MODEL MARINE FUEL TANKS

UL ASSIGNMENT 65WW63
File MM-36

UL ASSIGNMENT 65WW32
File MM-10

DATE: 27 February 1970

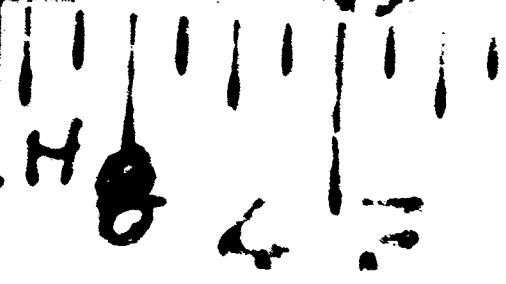
Final Inspection Report
FIG. NO. 8

Close-up views of perforations indicated by Nos. 2 & 3 in Fig. No. 6.

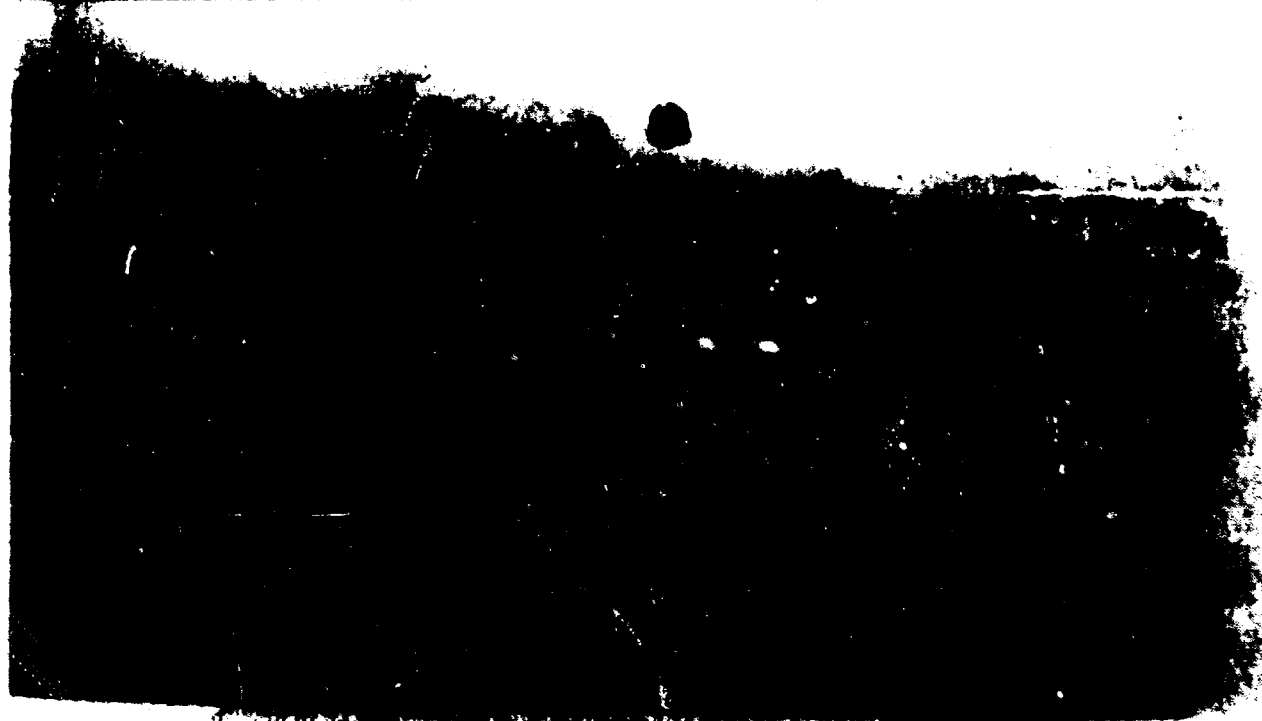
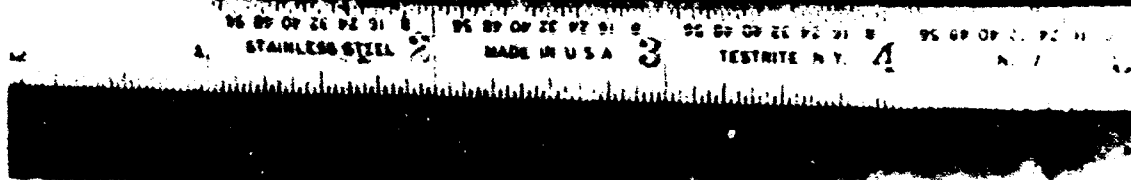
Close-up views of the two perforated areas indicated by
tape on Fig. No. 44.
